Belzona Know-How

FOR REPAIRING ERODED-CORRODED TUBE SHEETS

HEX-1

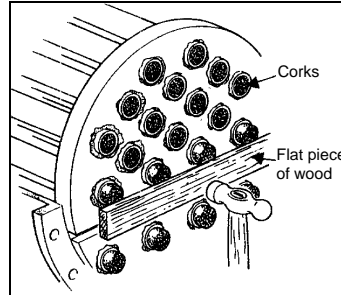
Fig. 1

On completion of blasting, wash the area with **Belzona® 9111** to remove all residual blasting debris. Block off all tubes taking care that the clean tube sheet is not contaminated. When all tubes are plugged, use a flat piece of wood to level the corks using the most protruding tube as a guide (fig. 1).

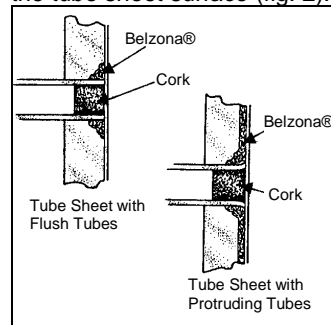
Fig. 2

Mix the selected Belzona® material and using the applicators supplied, apply to all eroded areas of the tube sheet to restore the original profile. Press the Belzona® well into the blasted surface to avoid air entrapment. Application should commence at the center of the tube sheet and progress to the extremities. In areas of the tube sheet where there are no tubes, then the Belzona® may be feathered down to the tube sheet surface (fig. 2).

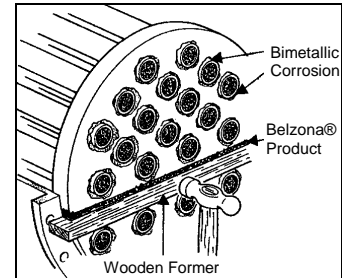
Fig. 3

Apply a thin film of Belzona® into the seal area pushing well into the blasted profile. Apply a further thin film of Belzona® material to the underside of the previously released former. Bed the former into position in the seal groove, clamp and apply further Belzona® around the former to restore the original seal groove dimensions. Following a suitable cure time, remove the former (fig. 3).

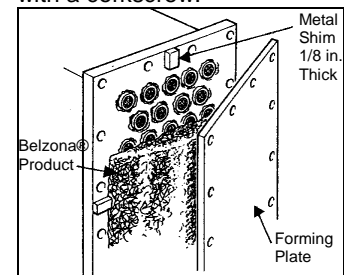
Fig. 4

Following preparation as outlined above, apply the selected Belzona® material to the tube sheet ensuring a peak of material at its centre. Apply a thin film of the chosen Belzona® material to the forming plate, which is then pushed against the tube sheet and pulled down to the correct position using existing flange studs or suitable clamps. Remove any exuded Belzona® and allow the System to fully cure before removal of the plate. Provided a minimum thickness of 1/8th of an inch (3 mm) of Belzona® has been applied using this method (fig. 4) there will be no necessity to apply a protective coating.
