Product Data

Multi-Purpose, Flexible Repair Composites

Belzona® 2200 Series MP Elastomer Systems 2211 and 2221

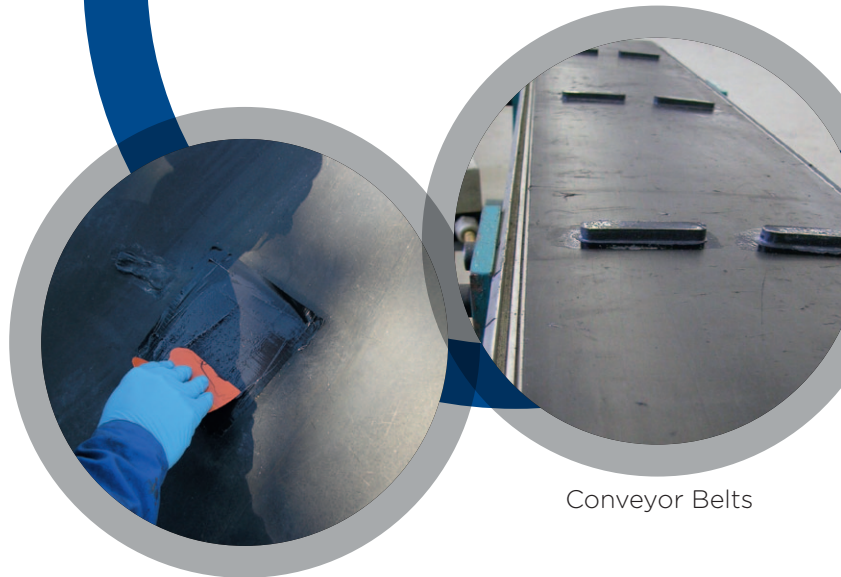
Bund Liners

Conveyor Belts

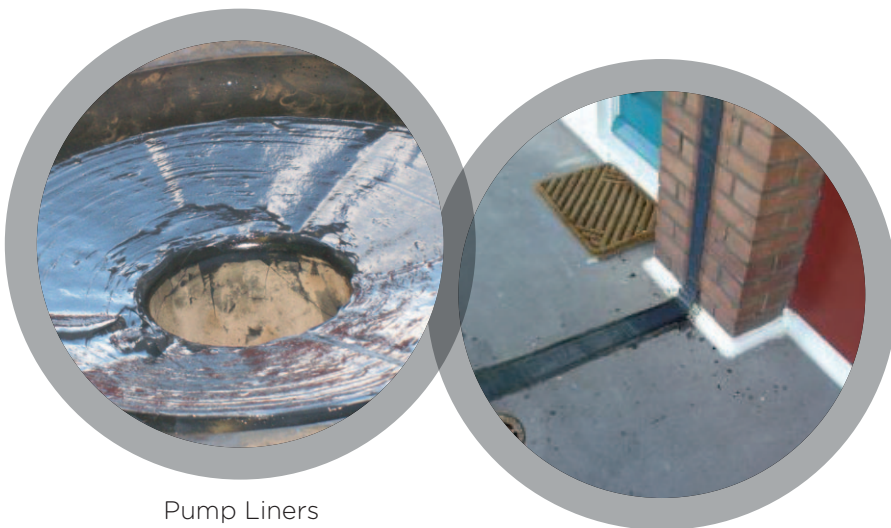
Pump Liners

Expansion Joints

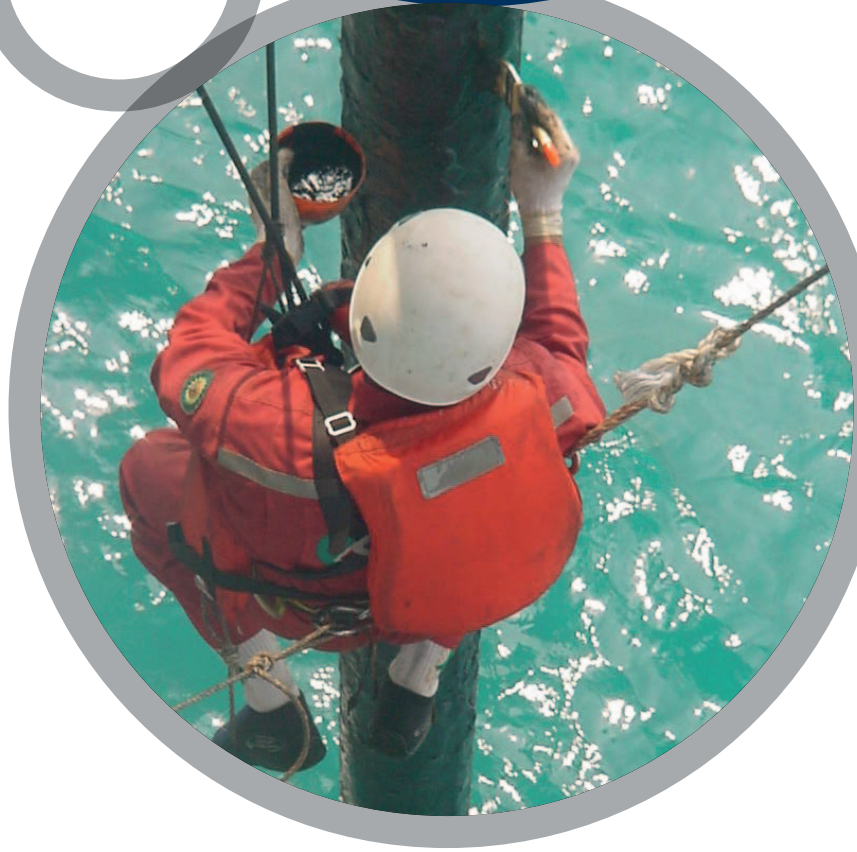
Riser Repair
