Belzona 3411

ENCAPSULATING MEMBRANE

Flexible, Peelable Coating System for the Protection of Flanges and Pipework

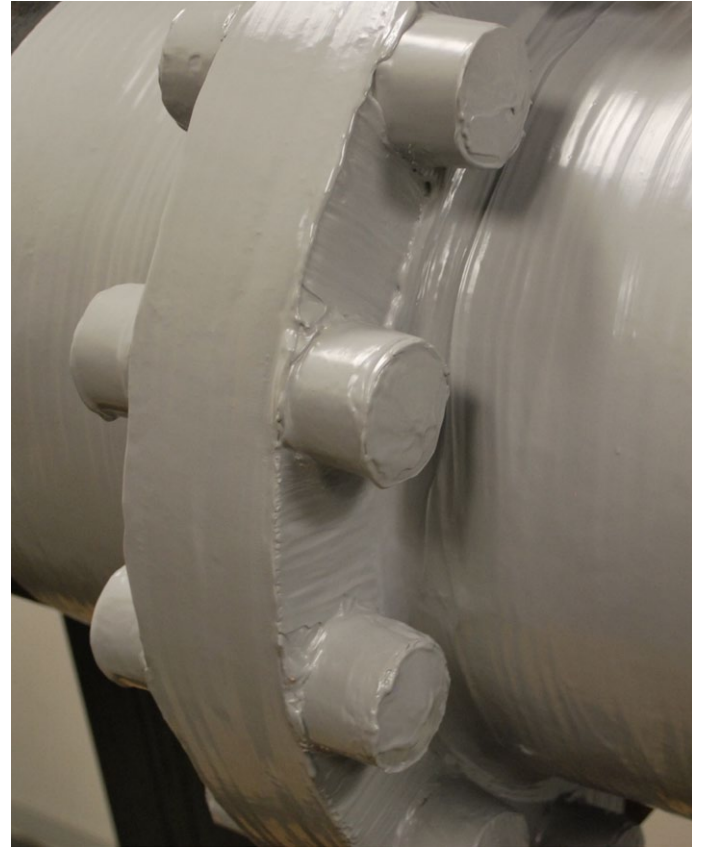
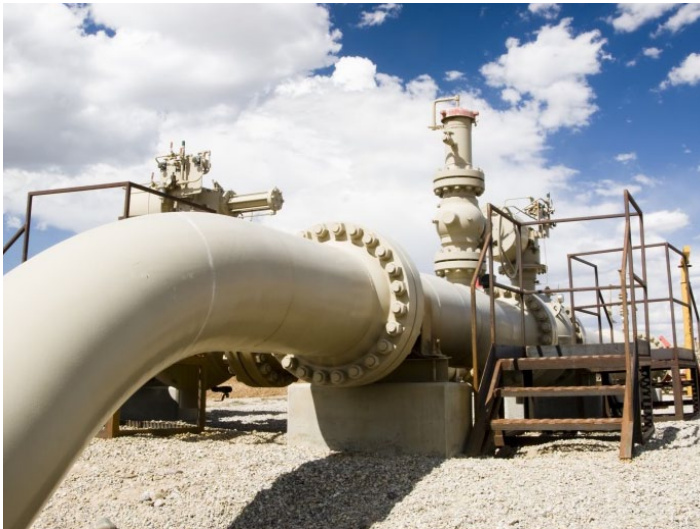
Belzona 3411 is a solvent-free hybrid polymer coating that can be used to completely encapsulate a flanged joint to protect it from the elements, exclude moisture and prevent corrosion. This liquid applied material does not require heat or specialist tools for its application, and reacts to form a tough elastic protective barrier.

When used with Belzona 8411, a corrosion-inhibiting base layer designed to work in combination with Belzona 3411, the system provides outstanding corrosion protection, and yet this peelable coating can be easily cut away with a knife to allow access to fastenings. Furthermore, after maintenance work has been completed the protective barrier can be readily reinstated with application of a further layer of Belzona 3411 over the cut joint.
