# Repair System for Protection Against Abrasive Attack

**BELZONA**  
1814

Belzona 1814 is a cost-effective three-component repair system for the protection of surfaces subject to abrasive attack.

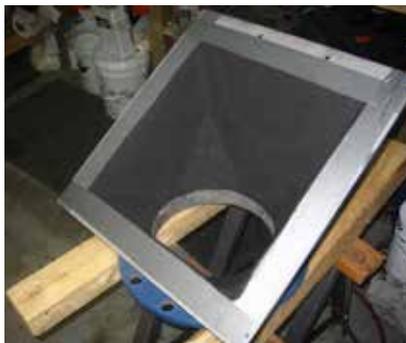
Protection for chutes and hoppers

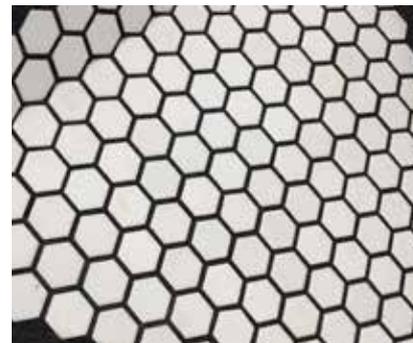
Grouting for alumina tiles

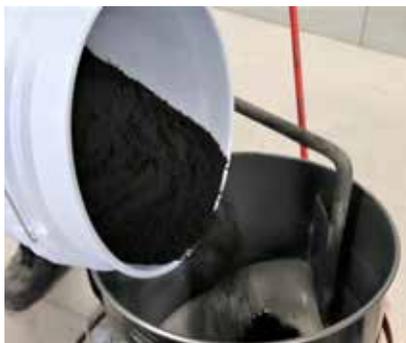
Simple mixing

Supplied as a three-part system, with a base, solidifier and aggregate, Belzona 1814 is easy to mix and apply without the need for specialist tools.

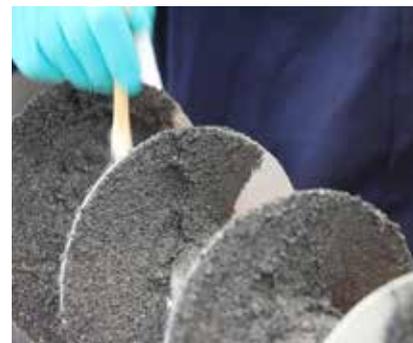
Easy application

The material is easy to mix and benefits from extended working life making it ideal for large areas. During application, no specialist tools are necessary and it is possible to apply thick and thin sections in one operation.
