Water-Activated Leak Sealing Kit

BELZONA[®]
9631

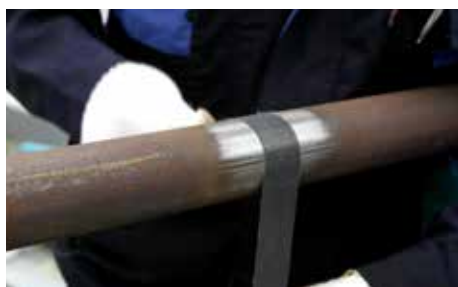
1. Roughen and clean surface

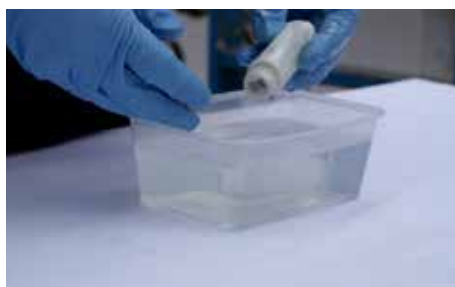
2. Soak wrap

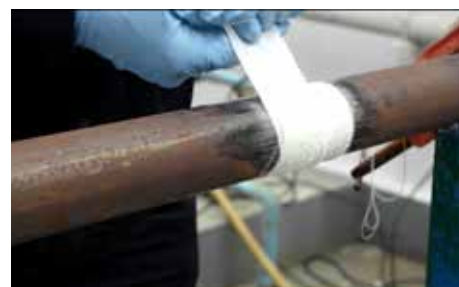
3. Apply wrap

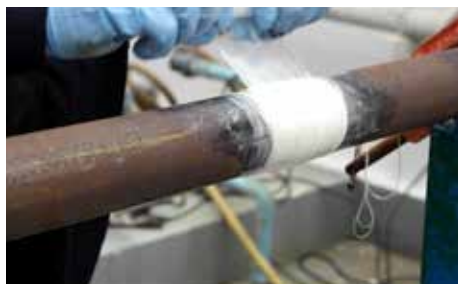
4. Apply film

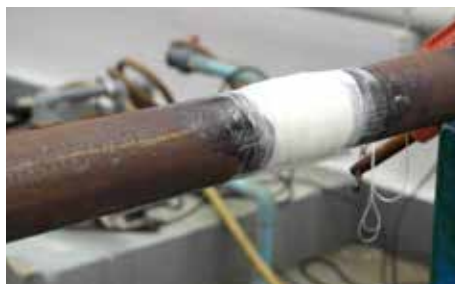
5. Application complete

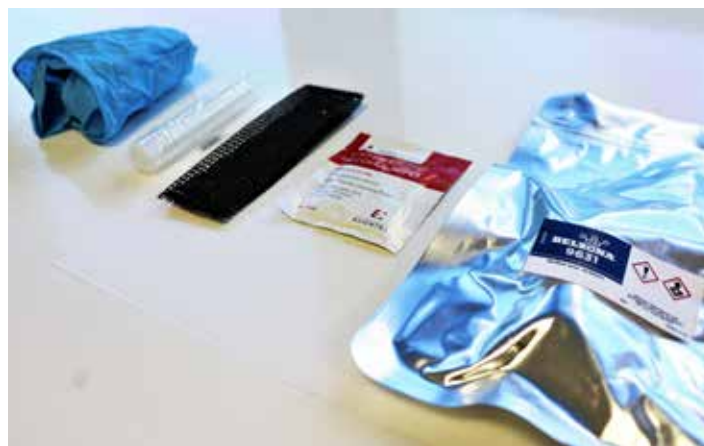
Kit contents (left to right) gloves, release film, roughing brush, cleaning wipes, water-activated wrap in a sachet

- Gloves
- Surface roughing mesh
- Cleaning wipes
- Water-activated wrap in a sachet
- Release film
